Contract #: 04-0120F4Cty: SF/ALA Rte: 80 PM: 13.2/13.9File #: 1.28**WELDING INSPECTION REPORT****Resident Engineer:**Siegenthaler, Peter**Address:** 333 Burma Road**City:** Oakland, CA 94607**Report No:** WIR-022470**Date Inspected:** 06-Apr-2011**Project Name:** SAS Superstructure**OSM Arrival Time:** 700**Prime Contractor:** American Bridge/Fluor Enterprises, a JV**OSM Departure Time:** 1530**Contractor:** American Bridge/Fluor Enterprises, a JV**Location:** Job Site**CWI Name:** See Report Below**CWI Present:** Yes No**Inspected CWI report:** Yes No N/A**Rod Oven in Use:** Yes No N/A**Electrode to specification:** Yes No N/A**Weld Procedures Followed:** Yes No N/A**Qualified Welders:** Yes No N/A**Verified Joint Fit-up:** Yes No N/A**Approved Drawings:** Yes No N/A**Approved WPS:** Yes No N/A**Delayed / Cancelled:** Yes No N/A**Bridge No:** 34-0006**Component:** Orthotropic Box Girders**Summary of Items Observed:**

WELDING INSPECTION REPORT

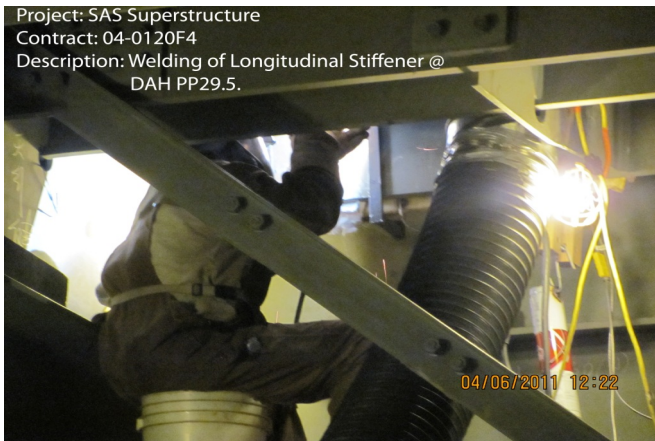
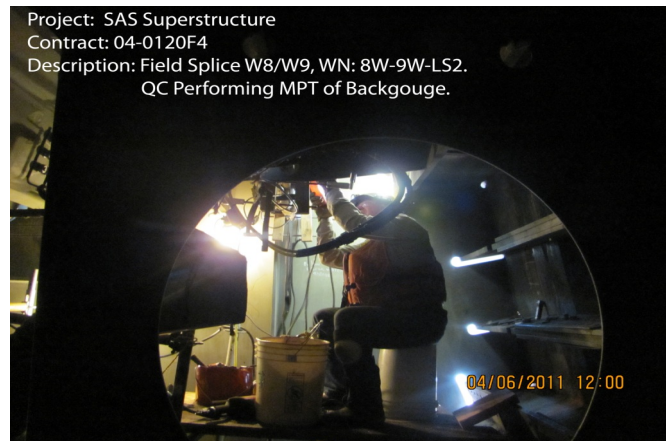
The QA Inspector observed the CJP welding of the longitudinal stiffeners located at the field splices W7/W8 and W8/W9 identified as WN: 7W-8W-A-LS3 and WN: 8W-9W-A-LS2. The welding was performed by the welders Xiao Jian Wan ID-9677 and Jin Pei Wang ID-7299 utilizing the WPS identified as ABF-WPS-D15-1012-3, Rev. 0. The welding parameters were verified by the QC inspector Gary Ehram and appeared to comply with the contract specifications. The CJP welding of the stiffeners was completed during this shift.

The QAI observed the fillet welding of the diverter plate located on the "A" deck of the OBG W4 along the grid line W2 at Panel Point 24. The welding was performed by Morgan Winters ID-3305 utilizing the WPS identified as ABF-WPS-F1200A, Rev. 2. The welding parameters were verified by the QC inspector Steve McConnell and appeared to comply with the contract specifications. The welding was not completed during this shift.

The digital photographs below illustrate some of the work observed during this scheduled shift.
